VW Beetle Luggage Panel Repair Tech Notes

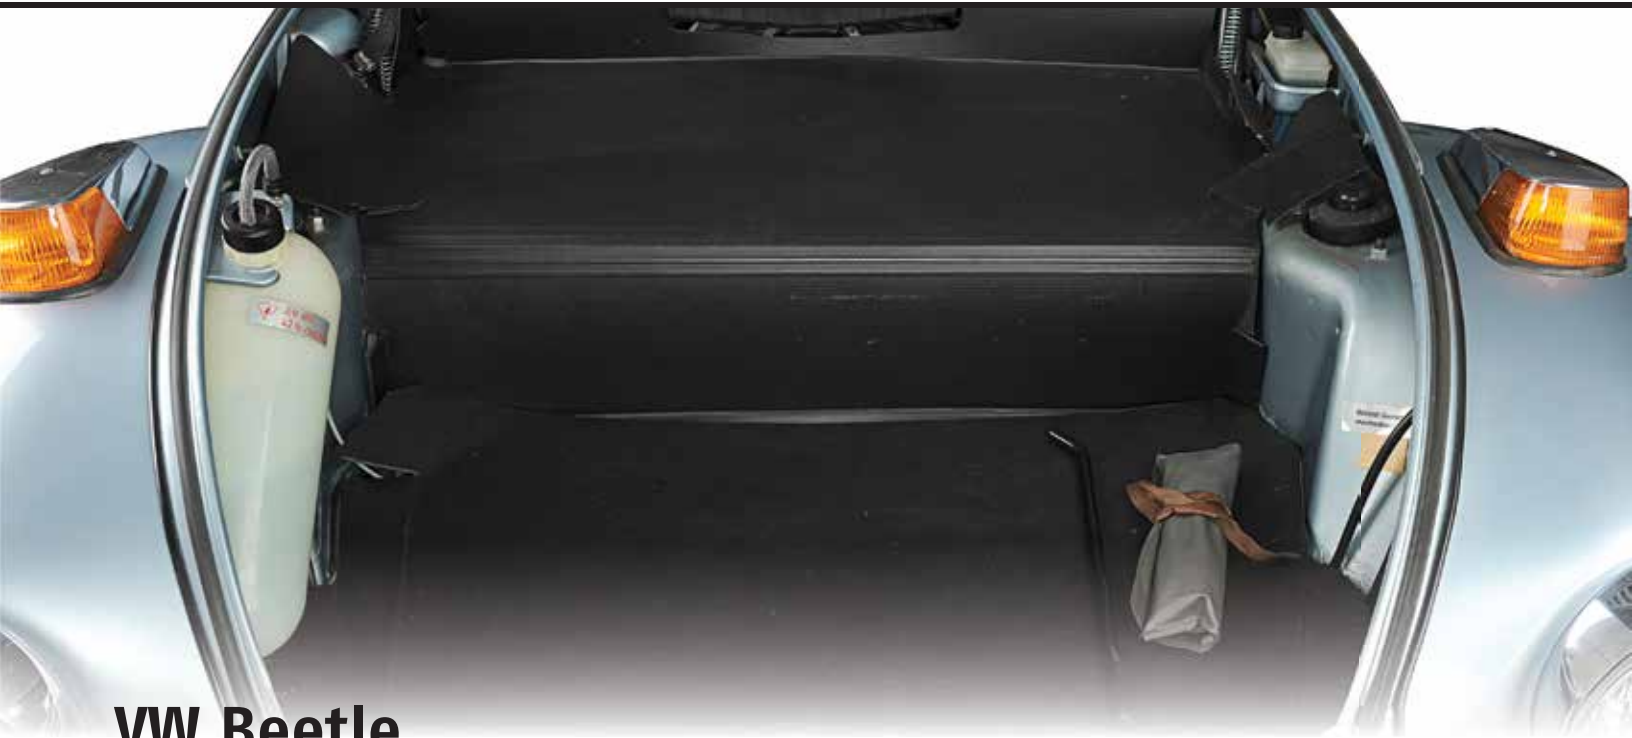
Tech Note: Watch out when cutting out the old sections of the luggage panel if you have an **Auto-Stick VW**. One of the main transaxle/torque converter fluid supply hoses sets directly under the driver side luggage panel. If you look close in this picture you can see where the cable goes into the back firewall. **MAM**

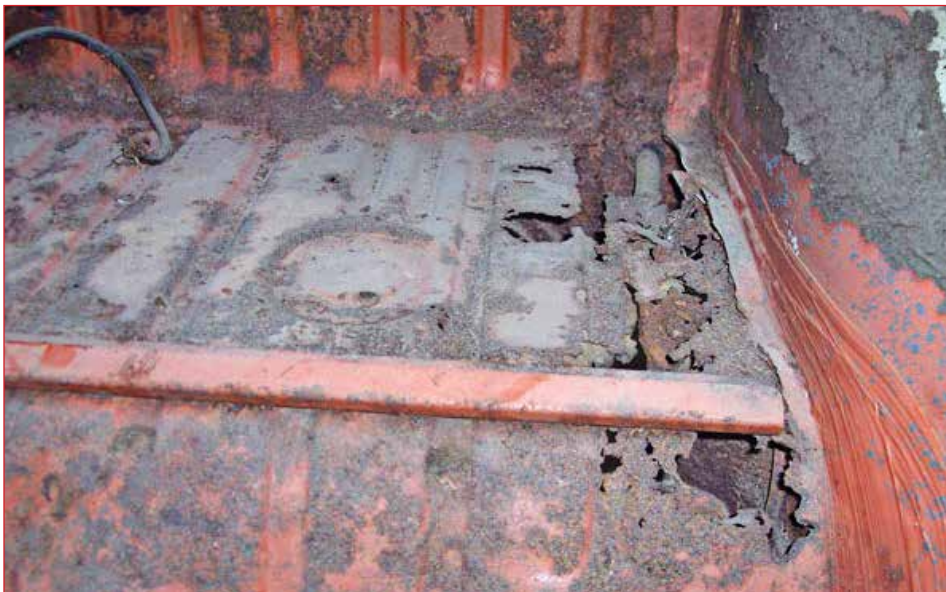
Luggage Compartment Shelf,
Rear, Repair Section.
(Drivers side or Passenger side)
Item # 321-192

Tech Note: Have a Beetle that the center part of the luggage repair panel is ok but the outer ends are rusted? We have a product that will make an effective repair without removing the entire luggage panel. Item number 321-192 is an outer repair section that will cover about 7 1/4" of the outer sides of the luggage panel and include about 3 1/2" of the inner fender at the highest point. Don't forget the seam sealant 106-016.

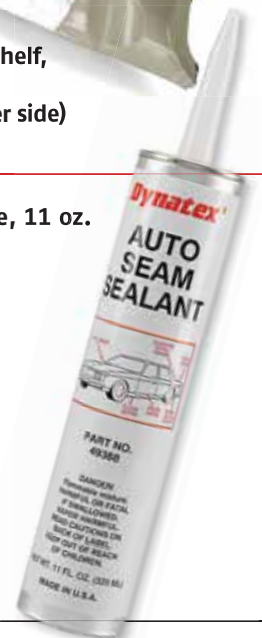
Auto Seam Sealant Tube, 11 oz.
Item # 106-016
