VW Tech Tips

VW Beetle Fender Identification Chart

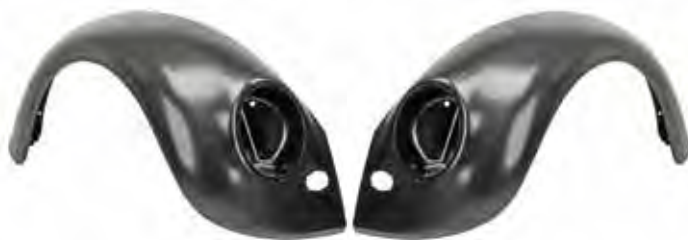
Slanted Headlight Bucket
1958-Early 1966

Front Right
OEM# 111-821-022 D
Our# 384-685

Front Left
OEM# 111-821-021 D
Our# 384-686

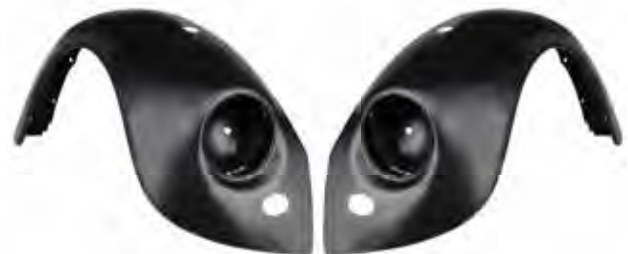
Vertical Headlight Bucket
Late 1966-1967

Front Right
OEM# 111-821-022 M
Our# 384-687

Front Left
OEM# 111-821-021 M
Our# 384-688

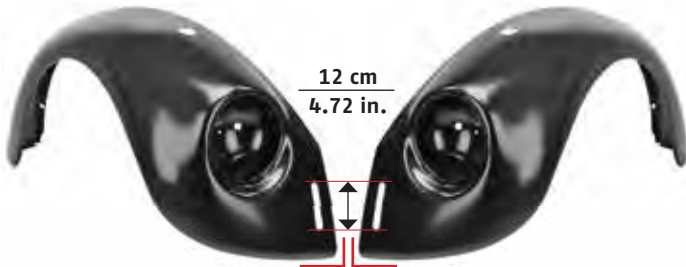
**Straight Lower Front
1968-1973 Standard Beetle**

Front Right
OEM# 113-821-022 M
Our# 384-689

Front Left
OEM# 113-821-021 M
Our# 384-690

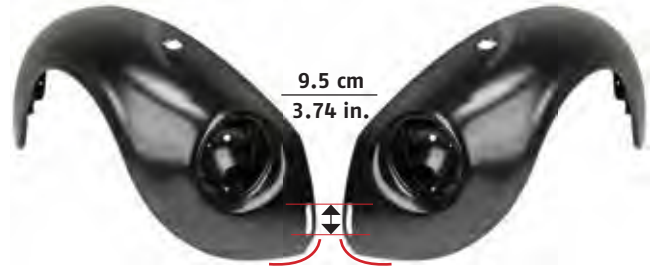
**Curved Lower Front
1971-1973 Super Beetle**

Front Right
OEM# 111-821-022 P
Our# 384-677

Front Left
OEM# 111-821-021 P
Our# 384-678

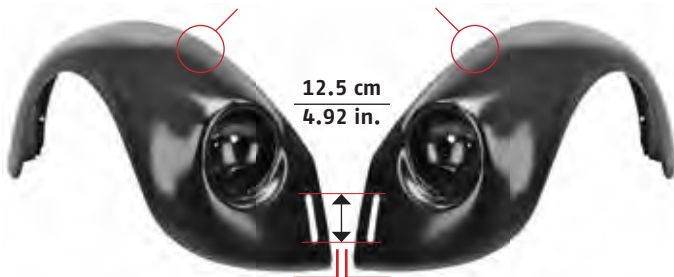
**Straight Lower Front
1968-1973 Mexican Style Standard Beetle
Does Not Have Cutout For Turn Signals**

Front Right
OEM# 113821022Q
Our# 390-812

Front Left
OEM# 113821021Q
Our# 390-811

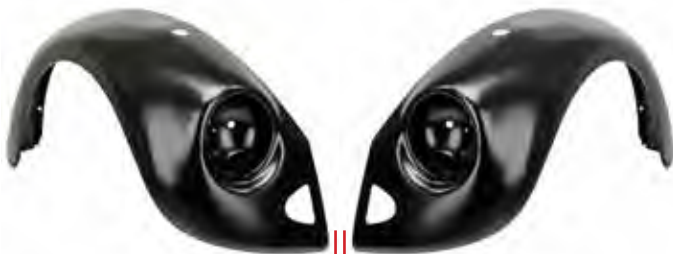
**Straight Lower front
1974-1977 Standard Beetle**

**Front Right
OEM# 113-821-022 P
Our# 384-691**

**Front Left
OEM# 113-821-021 P
Our# 384-692**

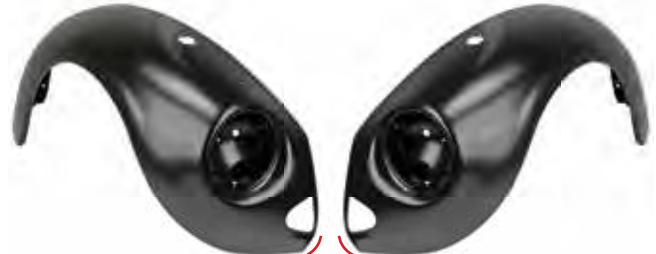
**Curved Lower Front
1974-1979 Super Beetle**

**Front Right
OEM# 133-821-022
Our# 384-679**

**Front Left
OEM# 133-821-021
Our# 384-680**

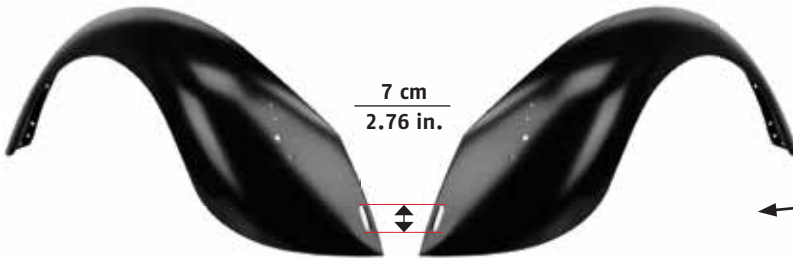
**without Bumper Overrider Holes
1949-1967**

Rear Left
OEM# 9510511
Our# 378-499

Rear Right
OEM# 9510512
Our# 378-502

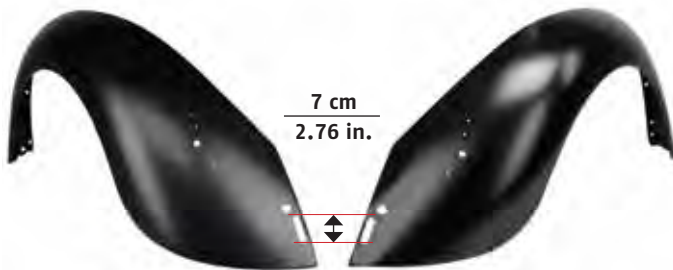
**with Overrider Hole and Slot
1958-1967**

Rear Left
OEM# 111-821-305 Q
Our# 384-693

Rear Right
OEM# 111-821-306 Q
Our# 384-694

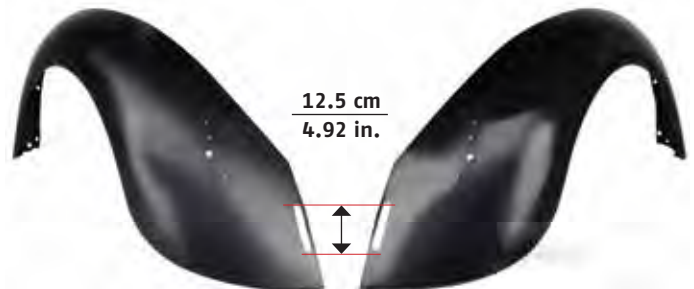
**Long Bumper Bracket Slot
1968-1972**

Rear Left
OEM# 111-821-305 L
Our# 384-696

Rear Right
OEM# 111-821-306 L
Our# 384-695

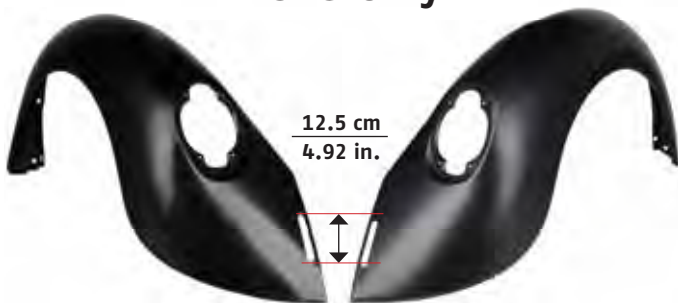
**Long Bumper Bracket Slot
1973 Only**

Rear Left
OEM# 111-821-305 M
Our# 384-698

Rear Right
OEM# 111-821-306 M
Our# 384-697

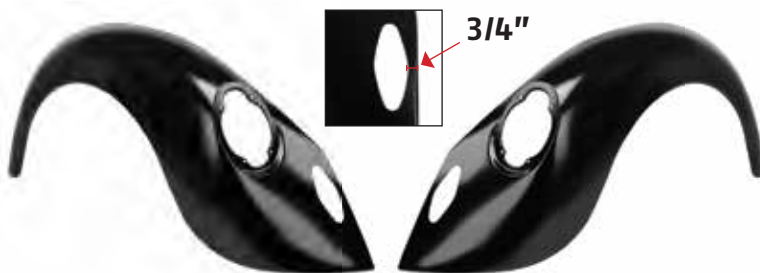
**Diamond Hole 3/4" from Edge
1974 Only**

Rear Left
OEM# 133-821-305
Our# 384-682

Rear Right
OEM# 133-821-306
Our# 384-681

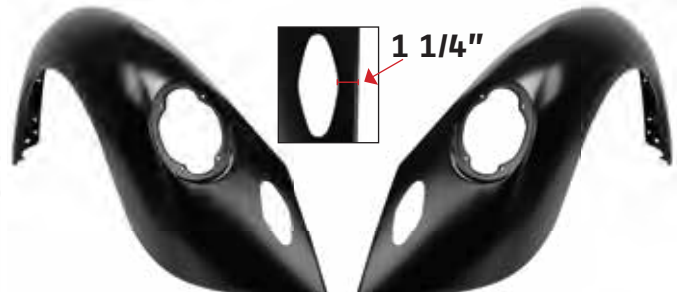
**Diamond Hole 1 1/4" from Edge
1975-1979**

Rear Left
OEM# 133-821-305 A
Our# 384-684

Rear Right
OEM# 133-821-306 A
Our# 384-683
