## A Rose By Any Other Name... Remedy Exhaust Fumes In Your VW!

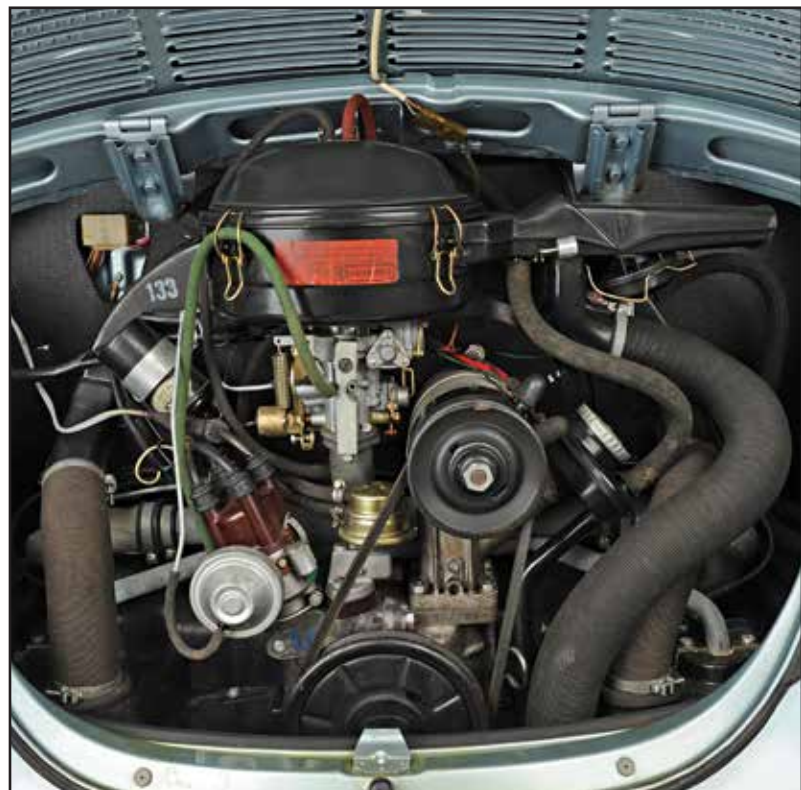
There may be an exhaust leak near the lower sleeve fittings going into the muffler (rear end of the heat exchangers), and this is sending blasts or exhaust air forward, towards the heat exchangers. The heat

exchangers are only pressed metal around the exhaust header and there are gaps that can allow squirts of exhaust gas to get in around the donut fittings. The male (header) part of those fittings DOES wear as the car ages and it becomes difficult to seal that joint. The end fittings eventually rust out too, but they can be replaced by hammer-in replacement stubs, which also give you a new gas-tight fitting into the muffler.
